4. TITLE (and Subtitle) DSCS II LLTWA Helix Current Anomaly		5. TYPE OF REPORT & PERIOD COVERED Final Report
		6. PERFORMING ORG. REPORT NUMBER 36060-AR-025

7. AUTHOR(s) P. H. Fowler		8. CONTRACT OR GRANT NUMBER(s) F04701-80-C-0022
9. PERFORMING ORGANIZATION NAME AND ADDRESS TRW Space and Technology Group One Space Park Redondo Beach, CA 90278		10. PROGRAM ELEMENT, PROJECT, TASK AREA & WORK UNIT NUMBERS

DSCS II LLTWA HELIX CURRENT ANOMALY

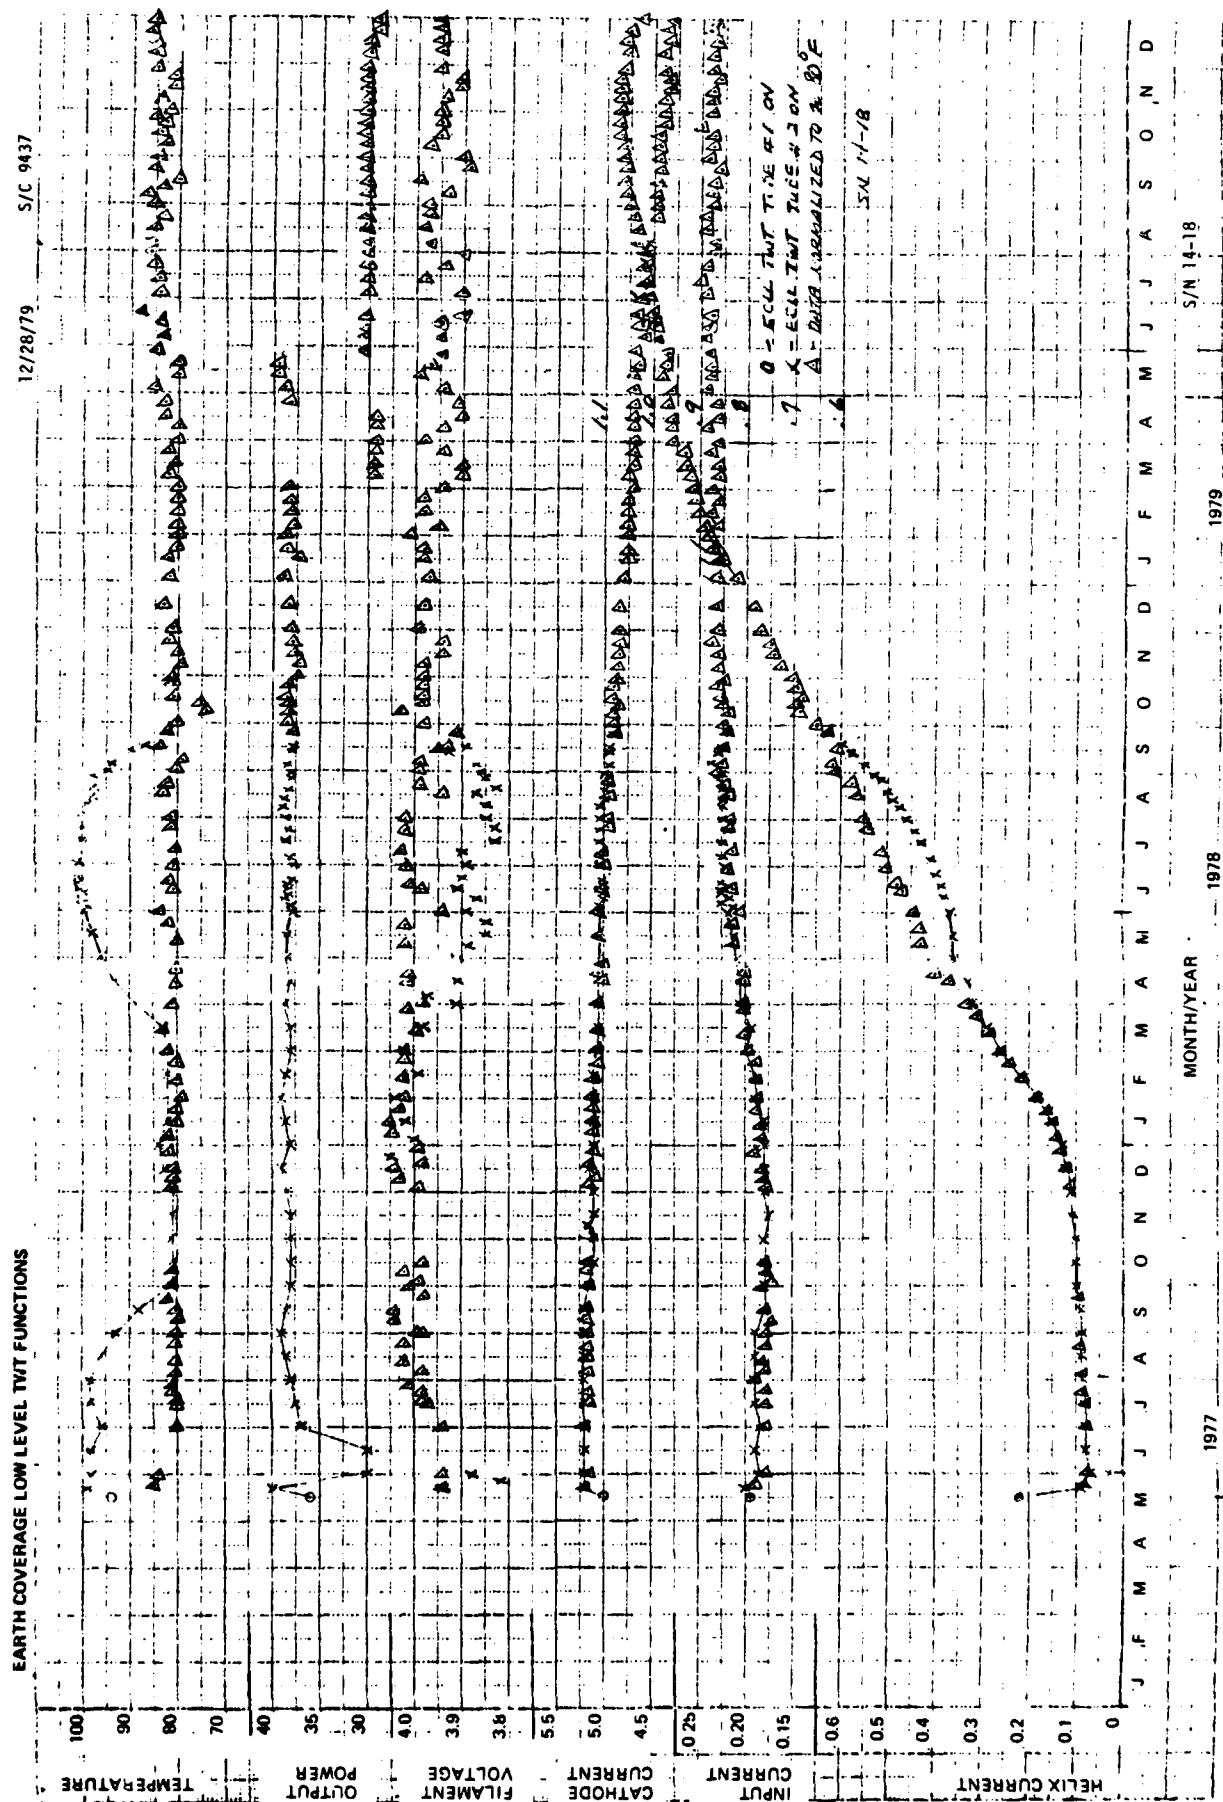
Figure 1

Figures 1 thru 7 show the significant telemetry indications from the amplifiers showing the problem. Note there are many other units in orbit whose performance has been stable for periods in excess of nine years. Experience with both the driver and power output tube in this and other programs shows that the problem is not intrinsic to the cathode type - lives well in excess of ten years appear to be routinely obtainable.

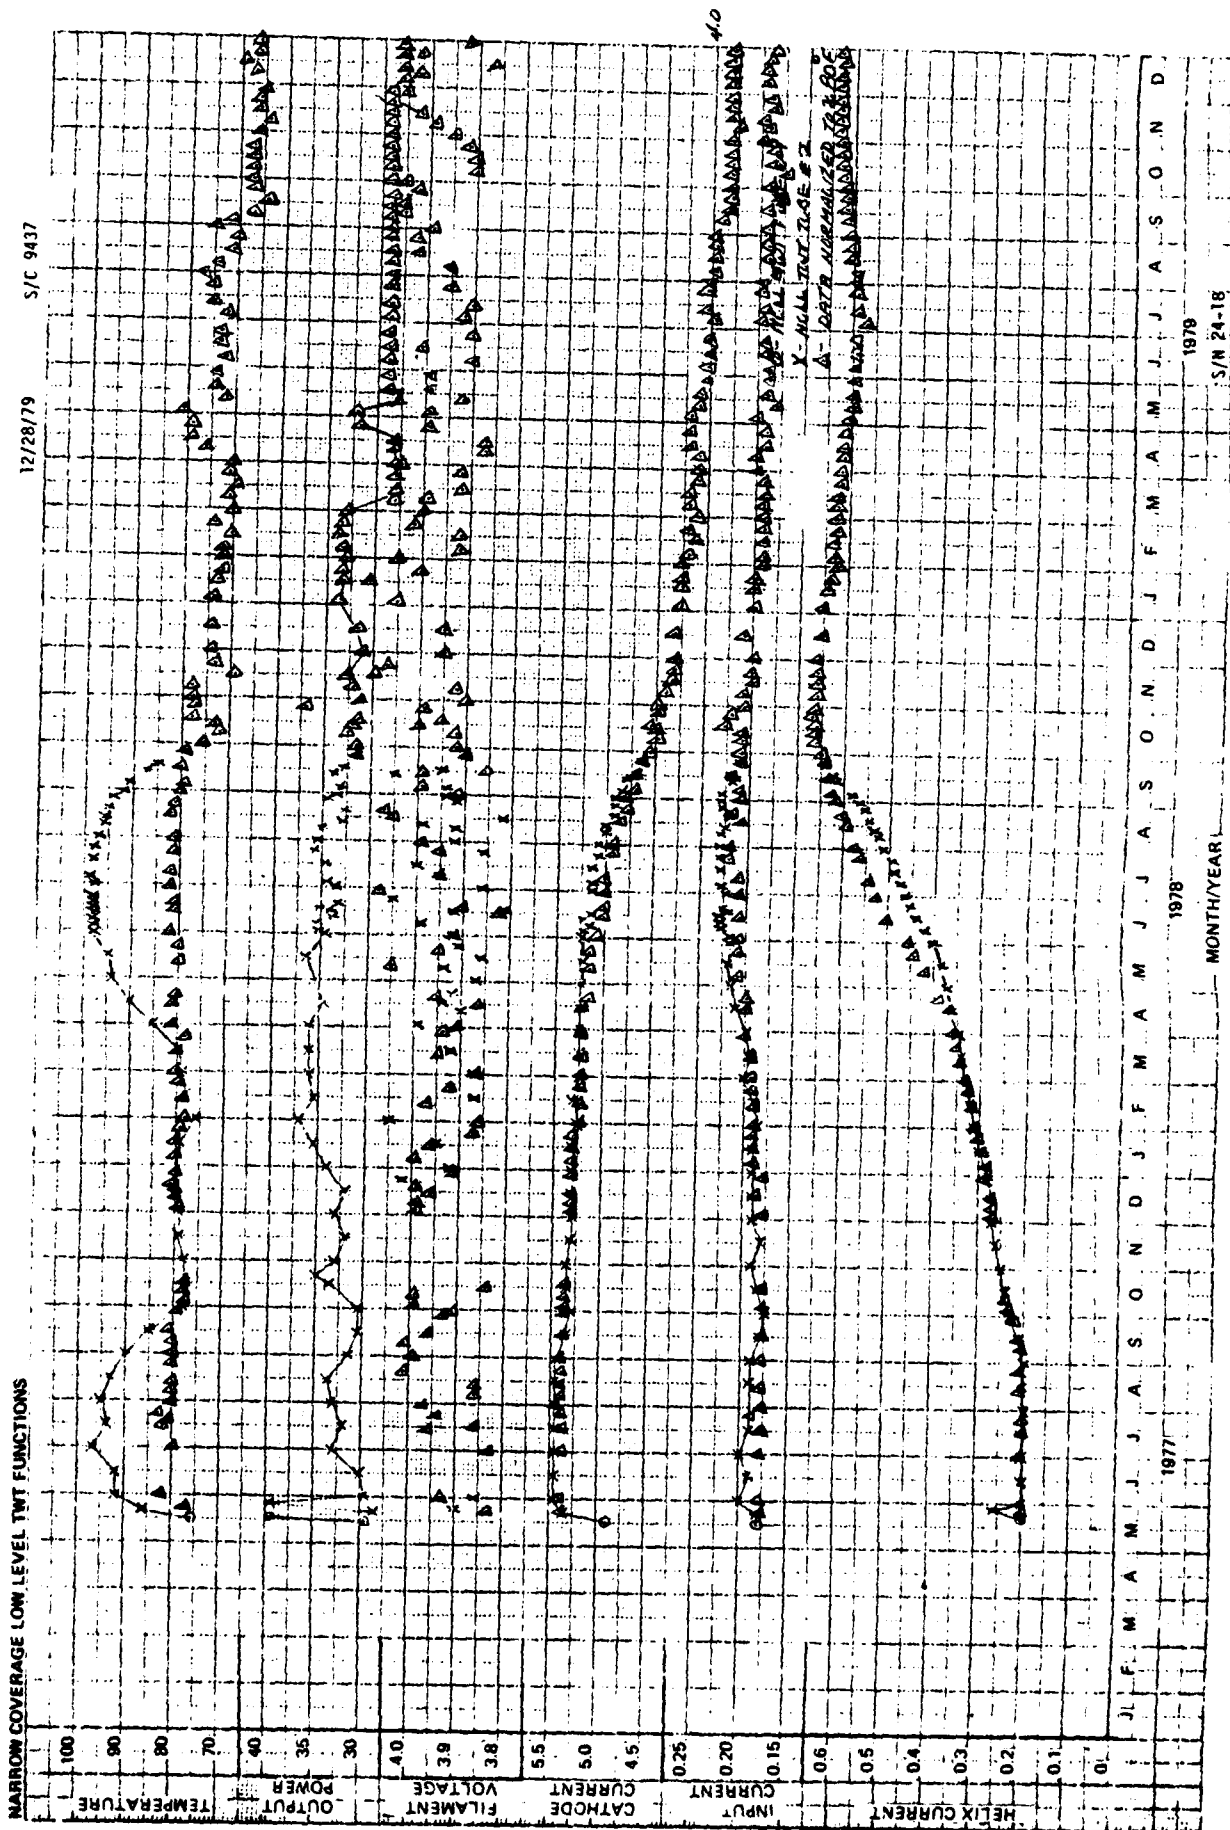
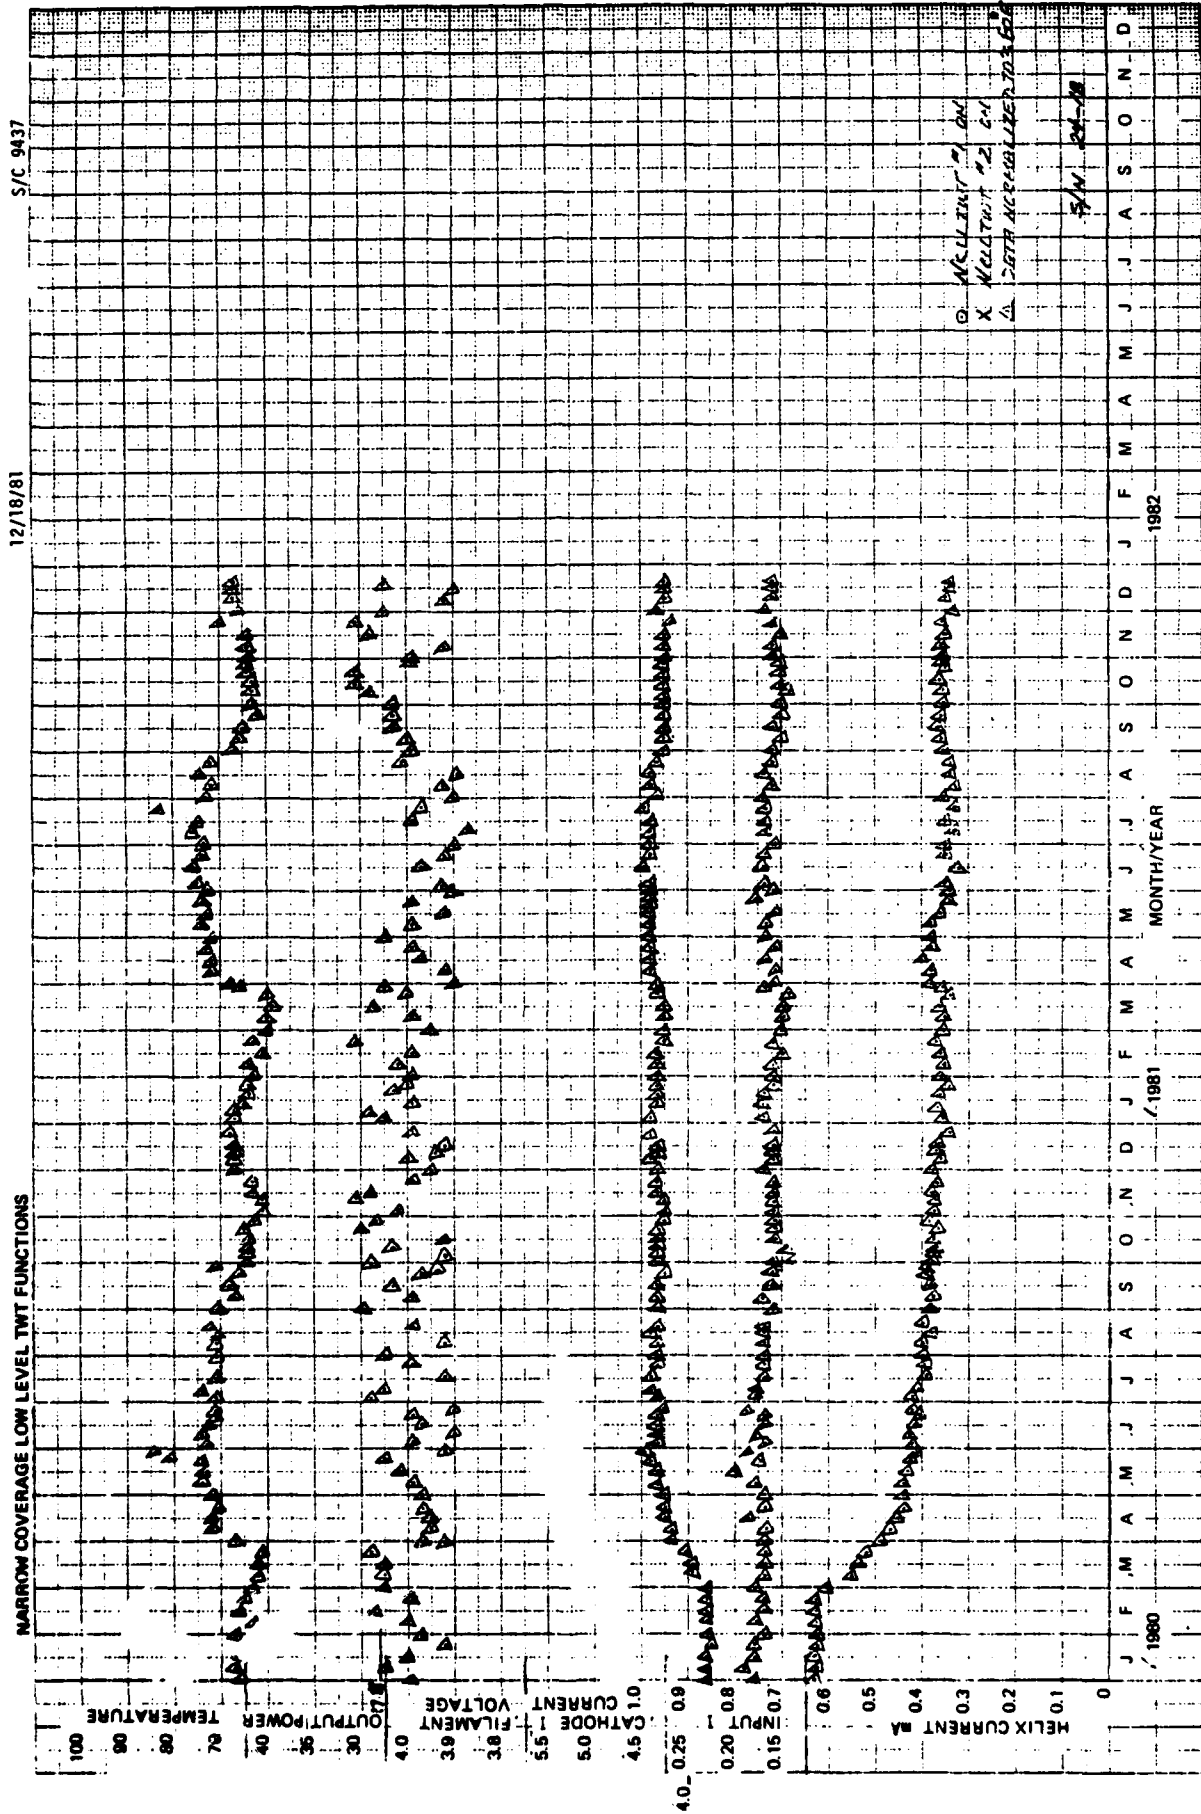
unusual interface resistance may result. As explained in Appendix I, Hughes concludes that this is the likely cause of the problem with the 263H tube. Note that a previous study (Reference 1) concluded that this was the probable mechanism, prior to a sample actually displaying the symptoms becoming available. Also note that the reversal of the helix current trend without a corresponding cathode current recovery is still difficult to explain. A possible explanation is that the increased voltage drop in the cathode produces the defocusing, but does not cause the majority of the drop in cathode current. Recovery of the resistance, e.g., by exhaustion of a thin layer of contaminant, then restores the tube focus. The drop in cathode current would, in this view, include a separate effect of the contaminant acting on the emitting surface. Recovery from this effect may be impossible, or may have a much longer time constant than recovery of the interface. Since no direct measurements or experiments have been made, this or any explanation is entirely speculative. Note, however, that Figure 2 shows at least one tube did have some cathode current recovery.

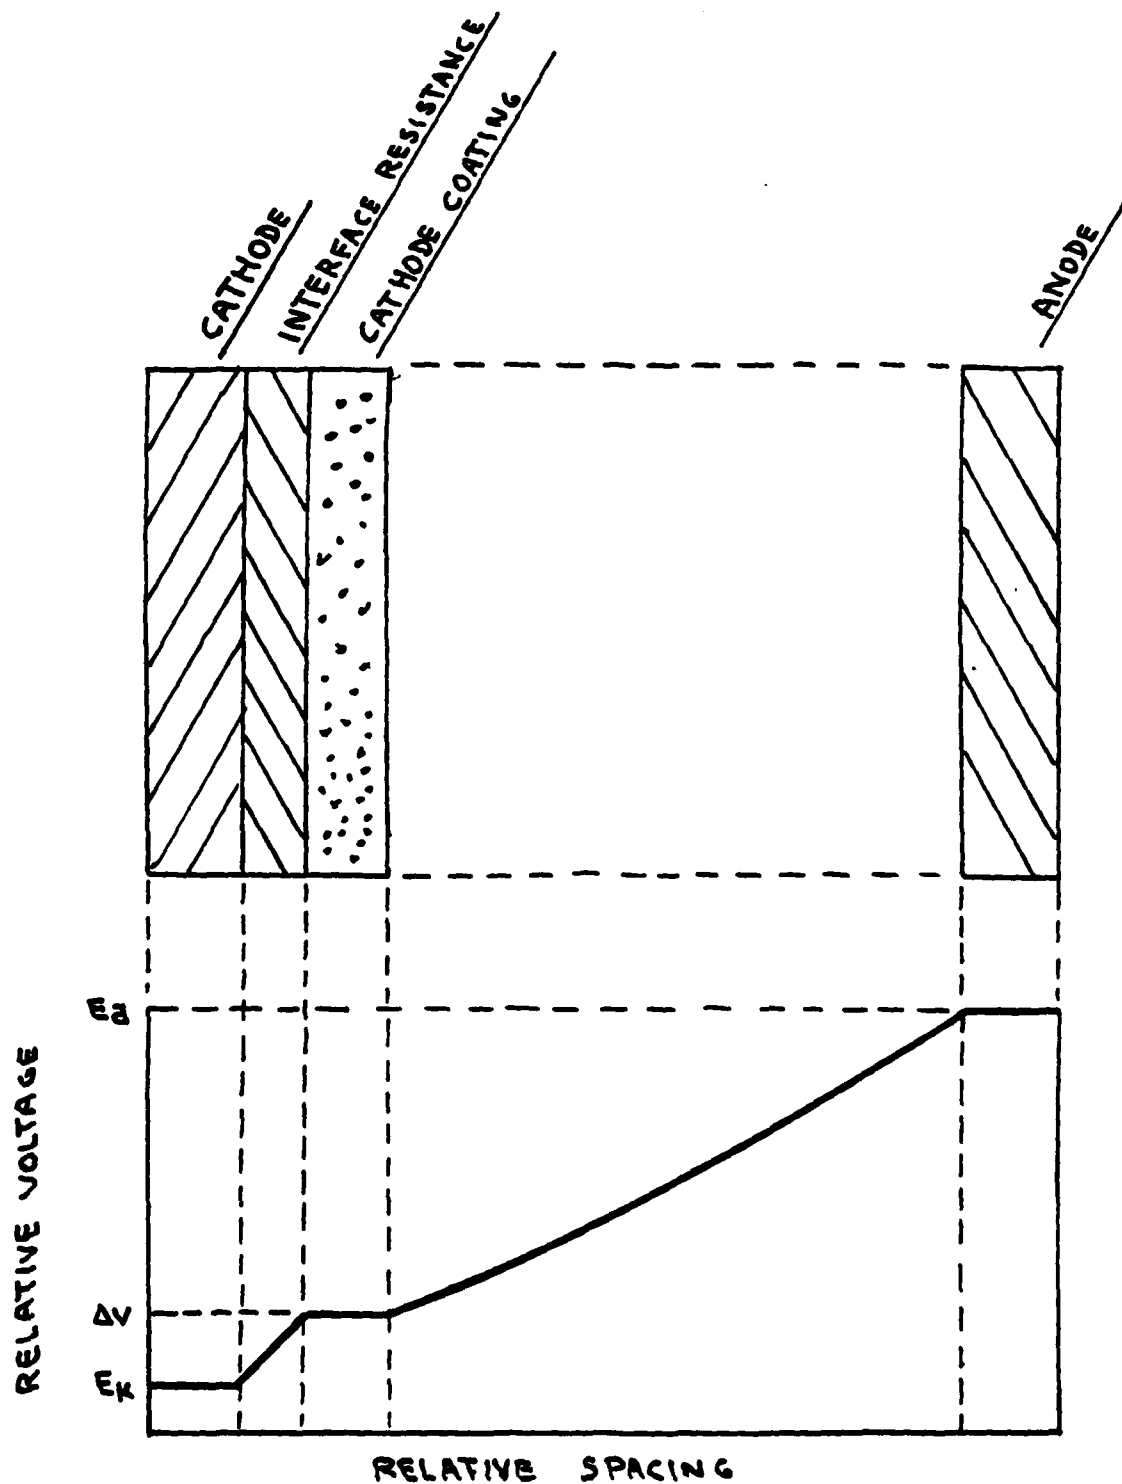
FIGURE 1. PHYSICAL LAYOUT OF A DIODE SHOWING AN INTERFACE RESISTANCE AND THE RESULTING POTENTIAL DISTRIBUTION.

8) An interface resistance can be depicted as in Figure 1. The voltage drop across the interface resistance causes the vacuum surface of the cathode coating to be closer to anode potential than the cathode itself. This causes cathode current to decrease as we noted on spacecraft 7 and 8.

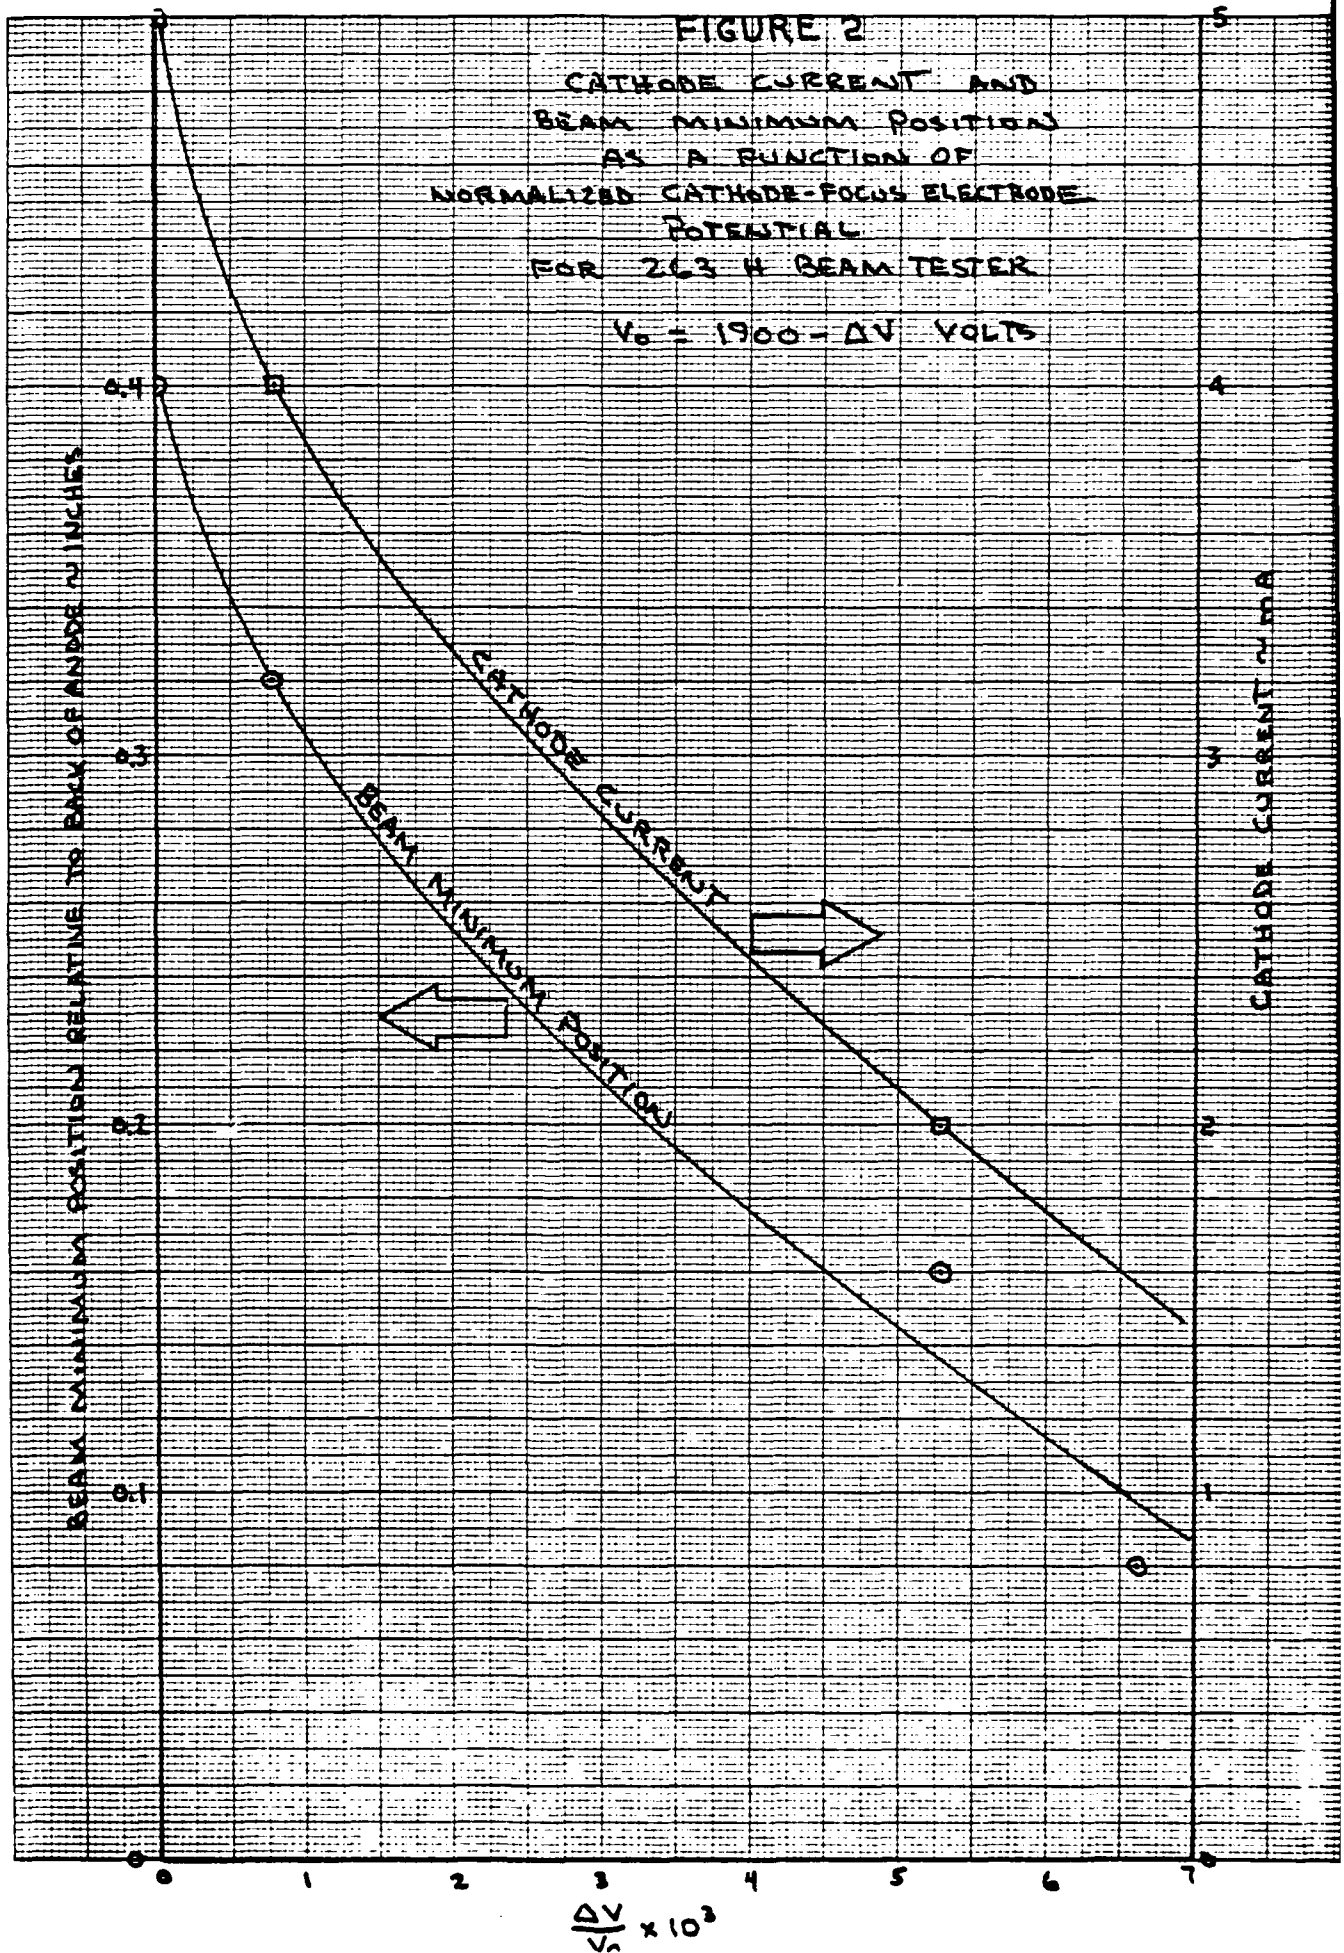
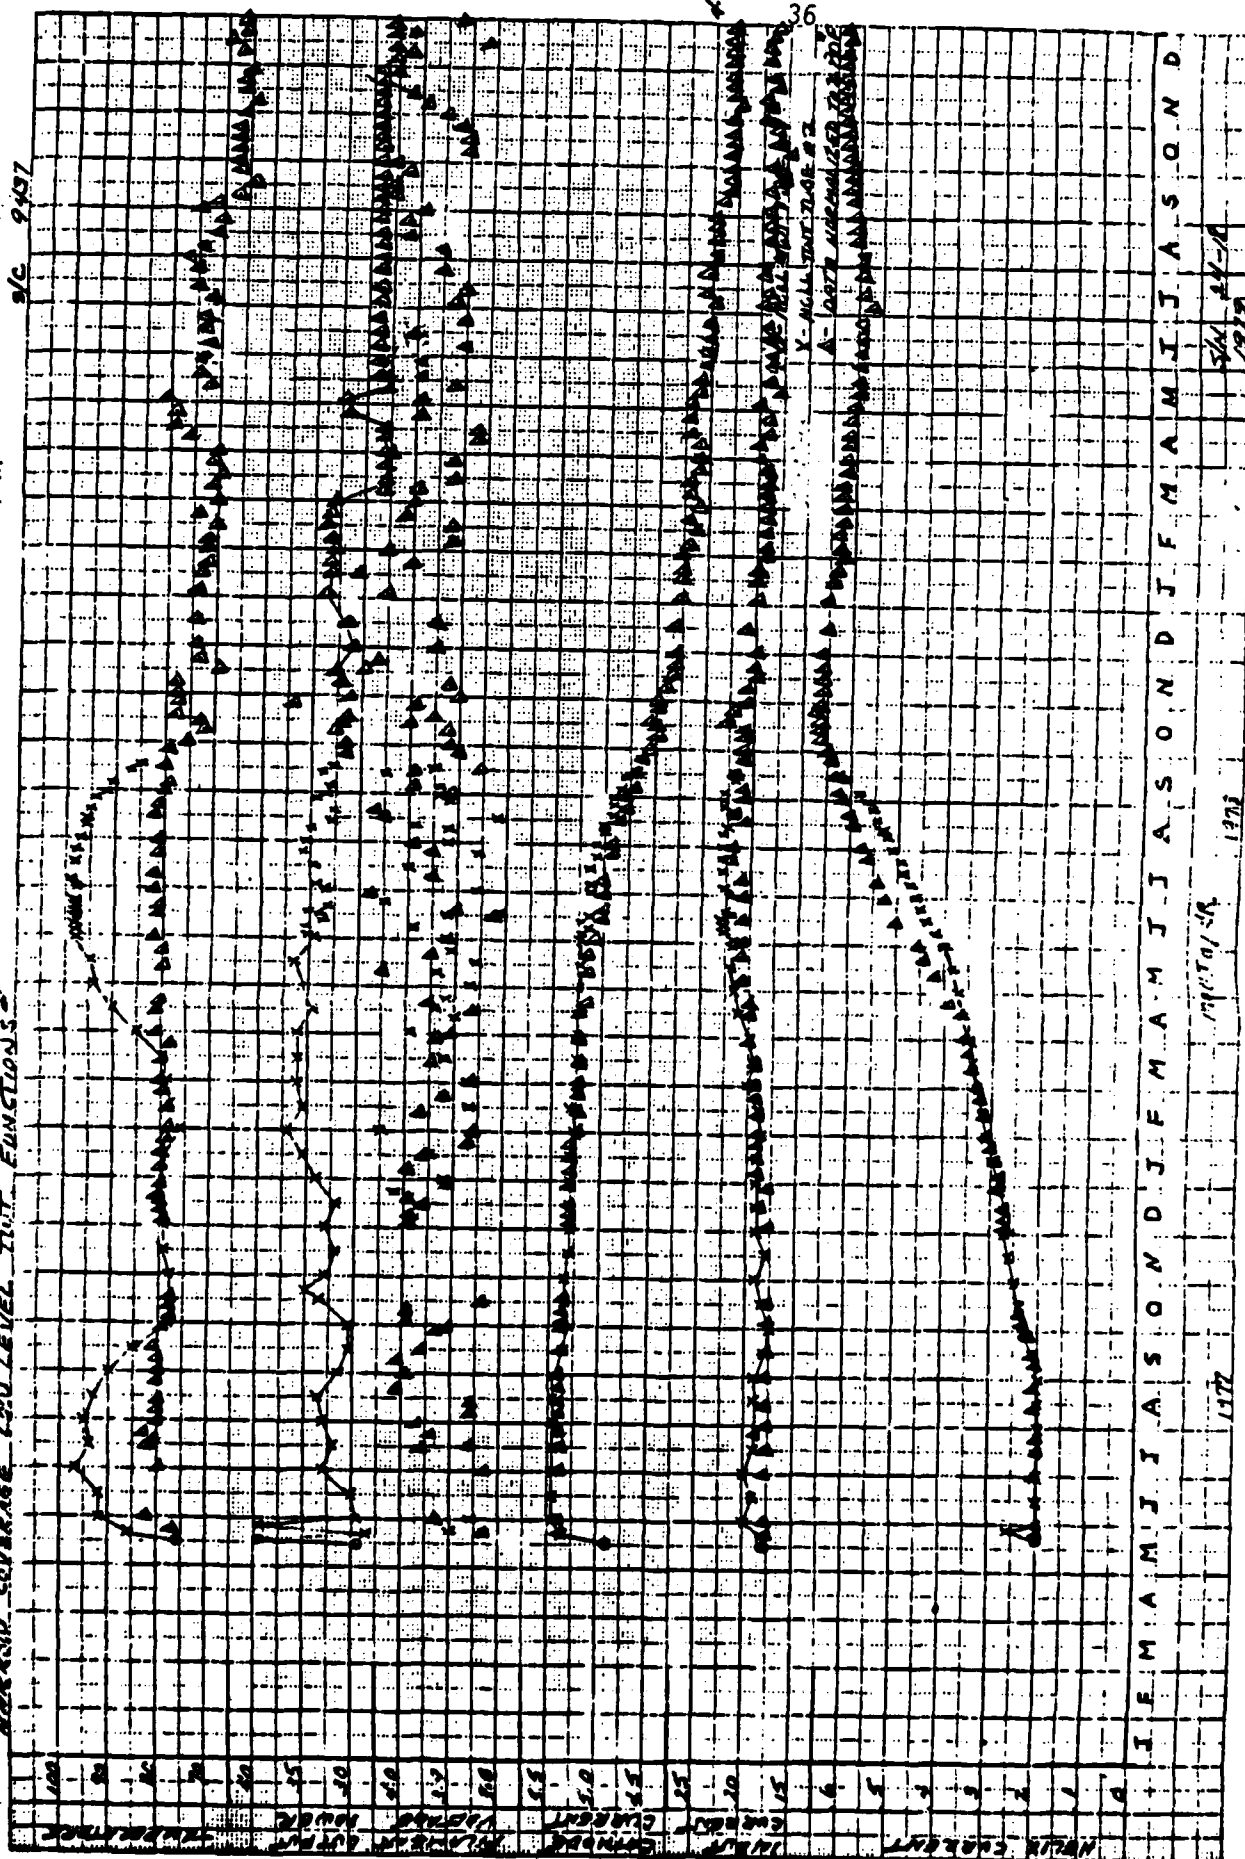
FIGURE 3

10) Consider the narrow coverage low level TWTA on S/C 9437 (Figure 3). According to the drop in cathode current from September 1977 to February 1980, the cathode resistance should have increased by about 580 ohms (approx. 16 ohms per sq. cm) and the beam minimum position should have moved toward the gun by 0.130 inches. With the magnetic half period of the PPM stack of 0.160 inches an appreciable defocussing would occur. From March 1980 to June 1981 the cathode current increased and reached a relative value of $\frac{4V}{V_0} \times 10^3 = 0.67$ or a resistance of about 230 ohms (approx. 6 ohms per sq. cm) and the beam minimum moved back about 0.070 inches toward the gun.

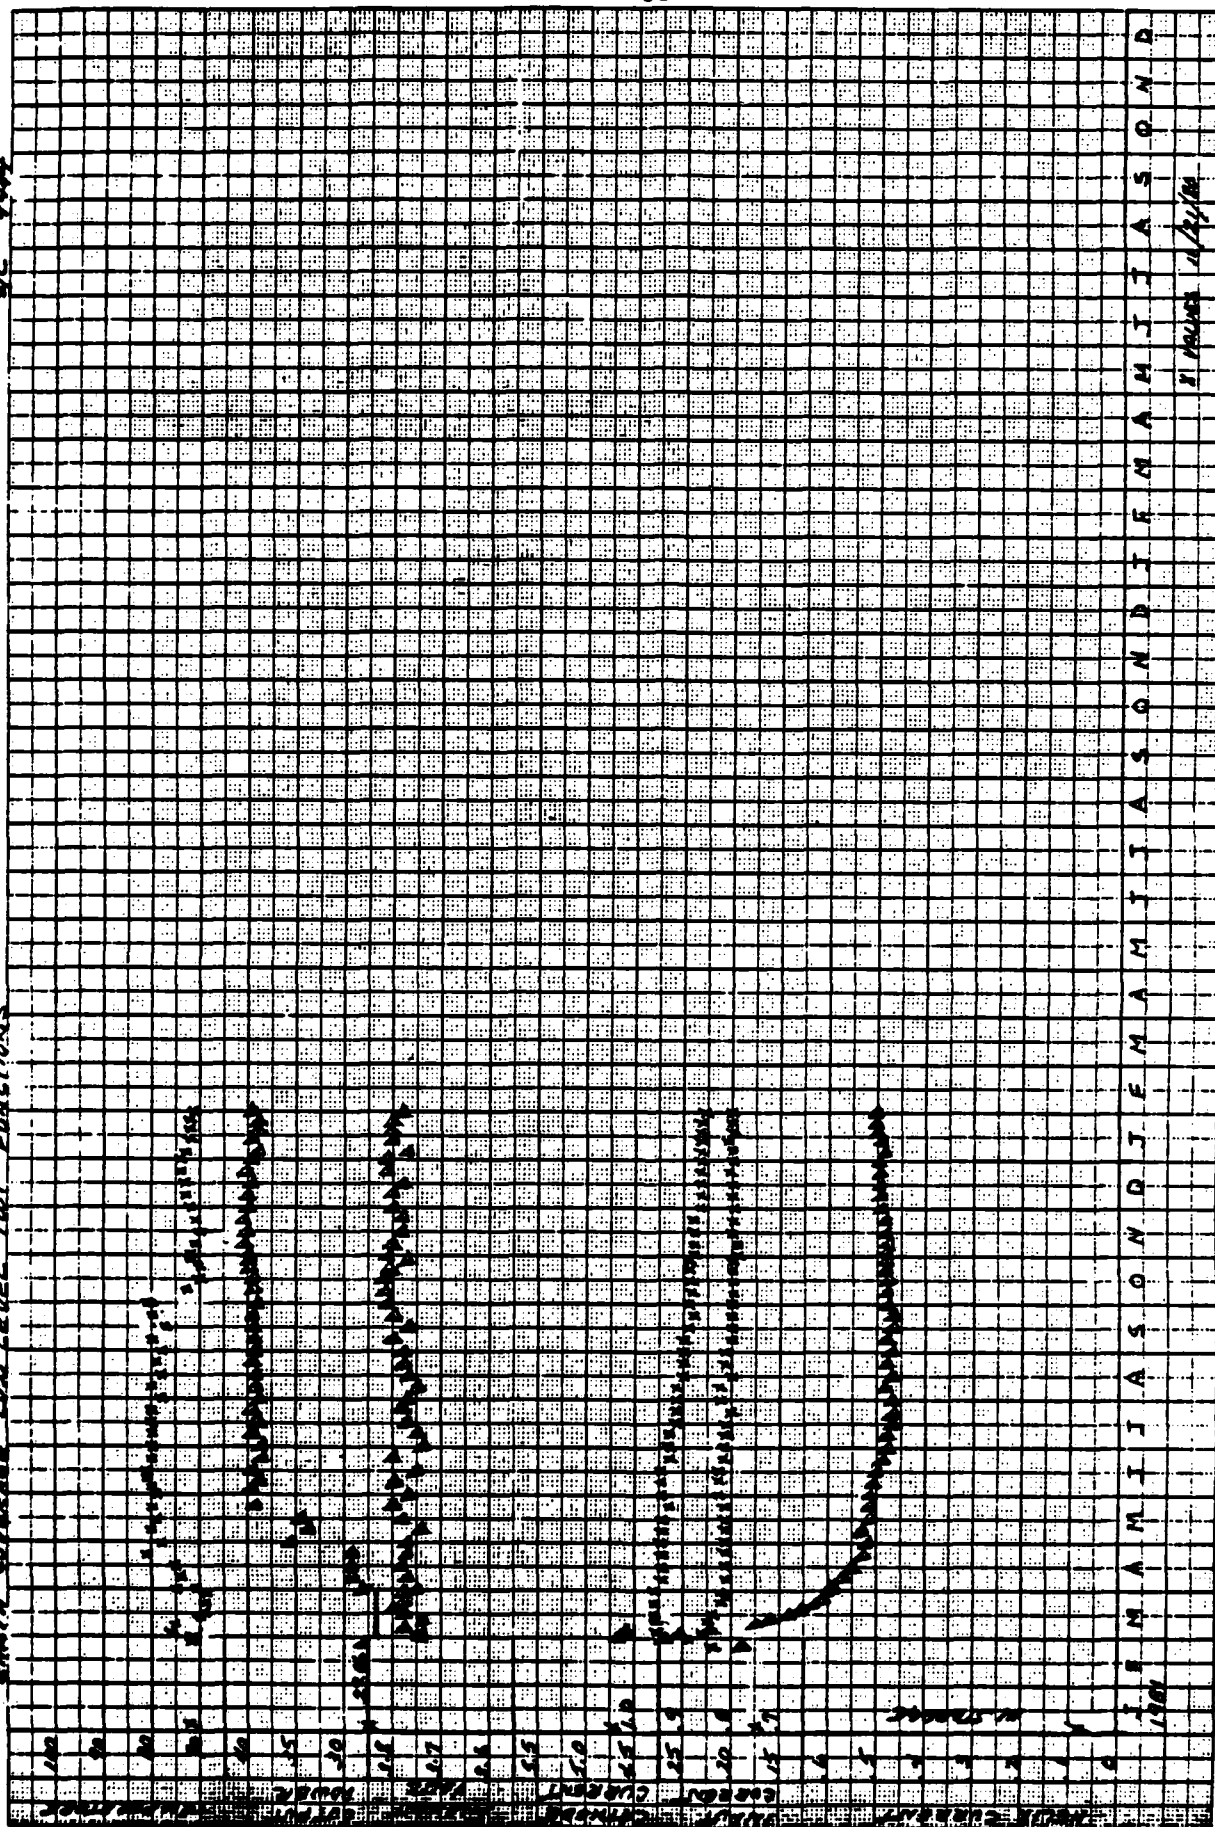
FIGURE 4

The mechanism on spacecraft 9444, TWTA 34-33 TWT S/N 299 (Figure 4) is very different from the previously described anomaly. The tube had run at a very constant level of helix current for about one (1) year prior to TWTA shut-down to store the spacecraft. When the TWTA's on the spacecraft were turned on, a drop in cathode current occurred from 4.7 mA before to 4.25 mA after. The helix change across the shut down was from .08 mA to .78 mA which then increased for a few days to a peak of 1.03 mA before dropping to a value of .5 mA. This type of behavior is indicative of a peeling cathode where peeling at one spot on the O.D. of the cathode can greatly affect the focusing and hence helix current.

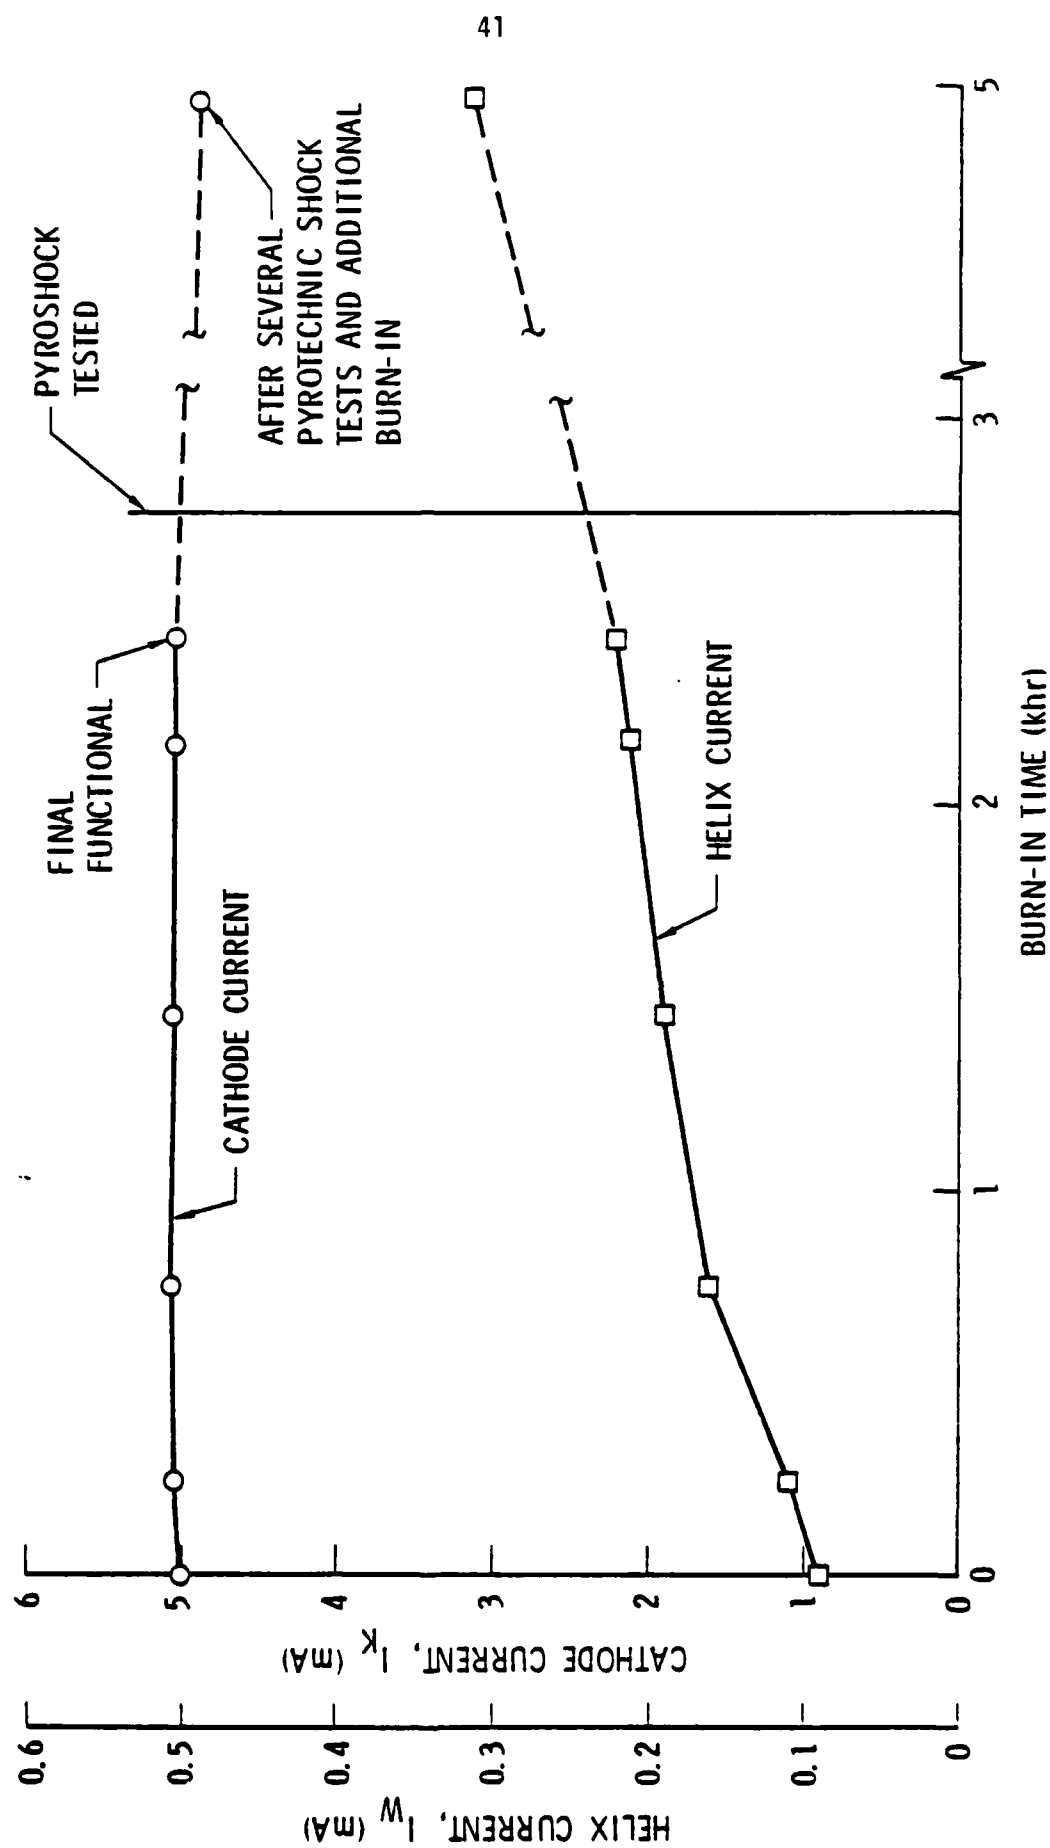
Fig. 7 Cathode and Helix Current Data for 263HA TWT SN245

The continuous rise of the helix current in 263HA TWT SN 245 during burn-in of LLTWTAs SN 24-23 does not appear to be the

result of residual gases in the tube. The gas content was reported by Graven and Gilmartin to be extremely low. After the TWT was depotted, a gas pressure of 2×10^{-8} Torr was measured by the modified Bayard-Alpert ion current measurement technique. The gas pressure increased to 5.7×10^{-7} Torr after attachment and bakeout of the puncture assembly. The constituents were identified as argon and helium which most likely were ion implanted in the collector during the early stages of tube operation but were released during depotting of the tube and bakeout of the puncture assembly prior to gas analysis. Thus, it is concluded that the TWT gas pressure during the burn-in phase was $\leq 2 \times 10^{-8}$ Torr.
